Supplementary Information Report Topolog-Luminita-Mesteru Wind Farm, Romania

Prepared for: Land Power

Prepared by: ENVIRON Italy S.r.I. Rome, Italy

Date: **October 10, 2013**

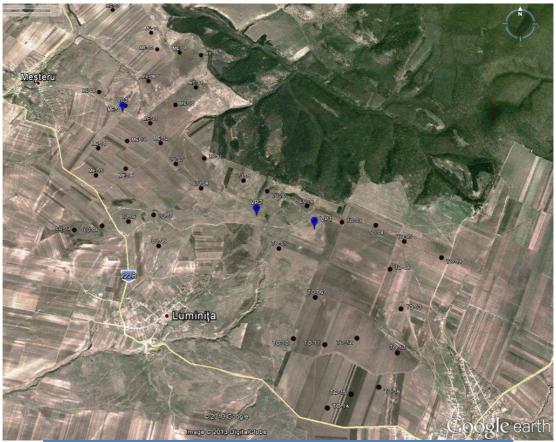
Figure 11: Vantage points

Vantage Points co	Vantage Points coordinates in WGS 84 system											
Observations points	Observations points Latitude Longitude											
Vantage Point 1	44 54.294	28 21.322										
Vantage Point 2	44 54.400	28 20.727										
Vantage Point 3	44 55.302	28 19.238

As reported in the Additional Study, the three Vantage Points (**Figure 11**) cover about 98% of the entire surface of to the project area, including also some areas outside it. Although, the locations of three turbines belonging to the Topolog cluster (TO-14, TO-15, TO-16) are virtually outside of the area visible from the nearest Vantage Point (VP1), the area where these three turbines will be located was kept under observation with the help of a spotting scope. Indeed, it was possible to carry out ornithological observations regarding the activity of birds, including (thanks to the altitude at which the VP is located) for the areas from the periphery of Topolog locality.

Furthermore, the three selected VPs indeed cover the critical areas, i.e.: 1. ecotonal area between the agricultural/grazing ecosystems and the woodland and 2. points at higher altitude. The not covered area is topographically depressed, with rather extensive agricultural activities (in some way more intensive than in other zone) and therefore less critic.
